**"Application of Linear Array Imaging Techniques to the Real-Time Inspection of  
Airframe Structures and Substructures"**

Final Progress Report: April 15, 1996

NASA Grant Number: NSG-1601

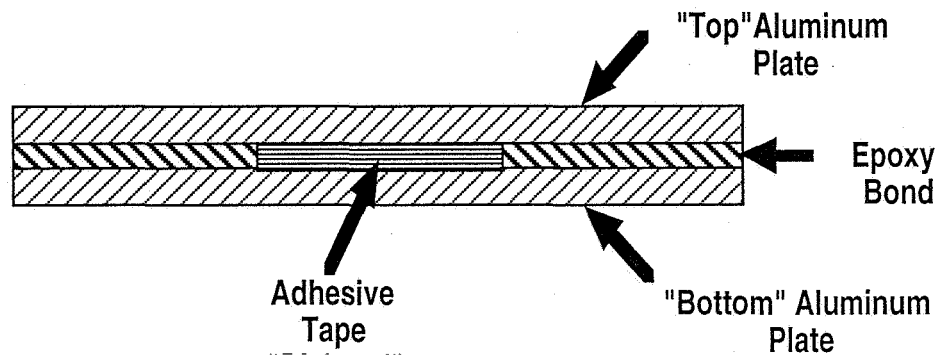
**Figure 1:** Cross-sectional representation of bonded aluminum plate specimen.

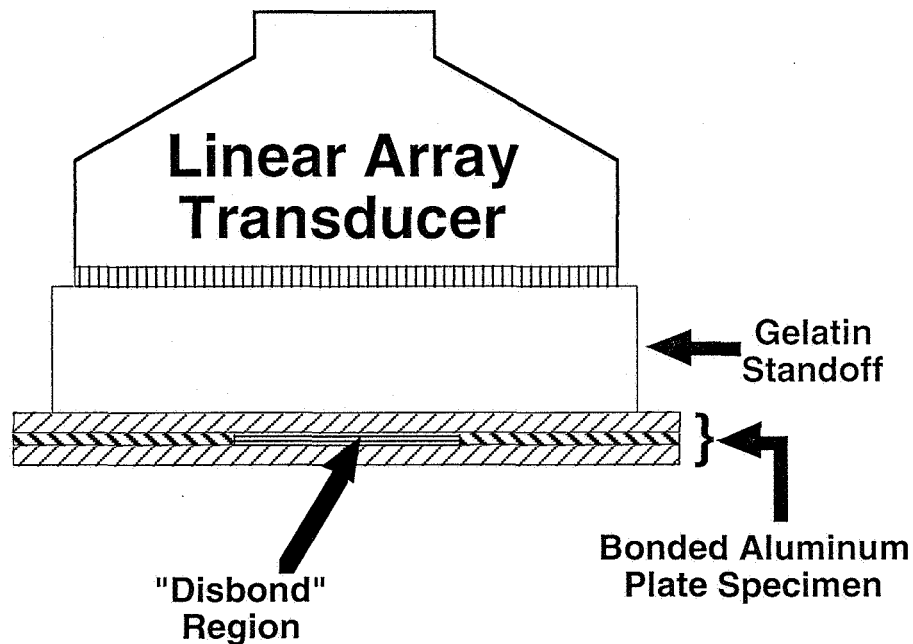
**Figure 2:** Configuration of linear array transducer and gelatin standoff for obtaining images of the disbonded region in the bonded aluminum plate specimens.

For these measurements a nominal 7.5 MHz center-frequency linear array probe was used with an overall length of 3.9 cm (1.5 inches). Each aluminum plate specimen was imaged with a gelatin stand-off approximately 2.54 cm (1 inch) in thickness between the linear array and specimen as illustrated in Figure 2. The gelatin stand-off was implemented to bring the front surface echo of the aluminum specimens closer to the center of the image. Each specimen was imaged with the axis of the linear array along the long axis (length dimension) of the specimen such that the linear array straddled the disbond region. The SONOS 1500 imaging system was configured such that the transmit power level was kept constant for all measurements and the same depth dependent gain (time-gain compensation) was applied to all depth segments and kept constant between the specimens. The video compression was adjusted to optimize the image contrast and remained constant for each specimen interrogated. The disbanded region and surrounding regions of each specimen were imaged from both sides of the specimen; i.e., each specimen was imaged from the aluminum plate side in contact with the adhesive of the masking tape ("bottom" side) as well as the side with no masking tape adhesive on the plate ("top" side).

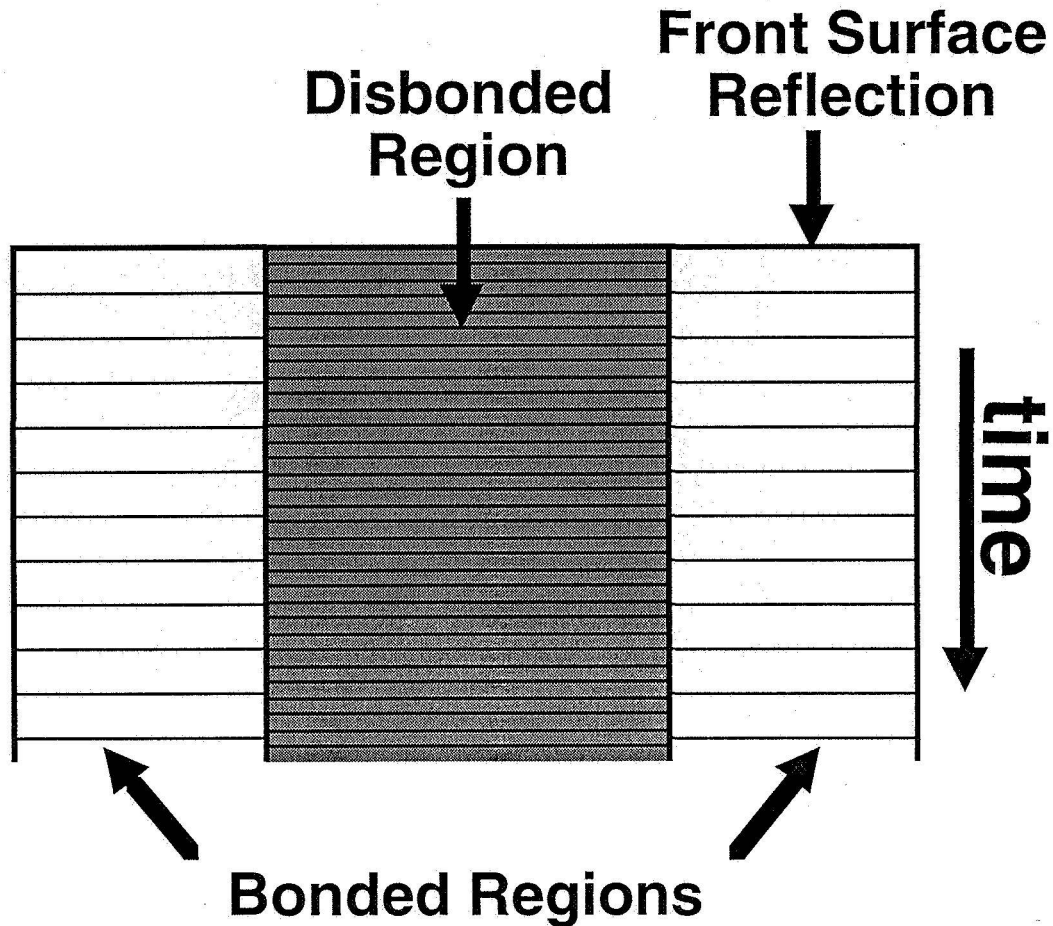
**Figure 3:** Cartoon illustrating how to interpret the linear array images.

Figure 3 illustrates how to interpret the images of the bonded aluminum specimens obtained with the linear array system. The images obtained from both sides of the specimen straddle the disbond region. The disbanded region is represented by the more darkly shaded area in Figure 3. On either side of the disbanded region is the well-bonded region, depicted as the more lightly shaded region in Figure 3. Recall that these images are composed of many reverberations of the ultrasonic signal in the specimen and do not represent a single cross-section.

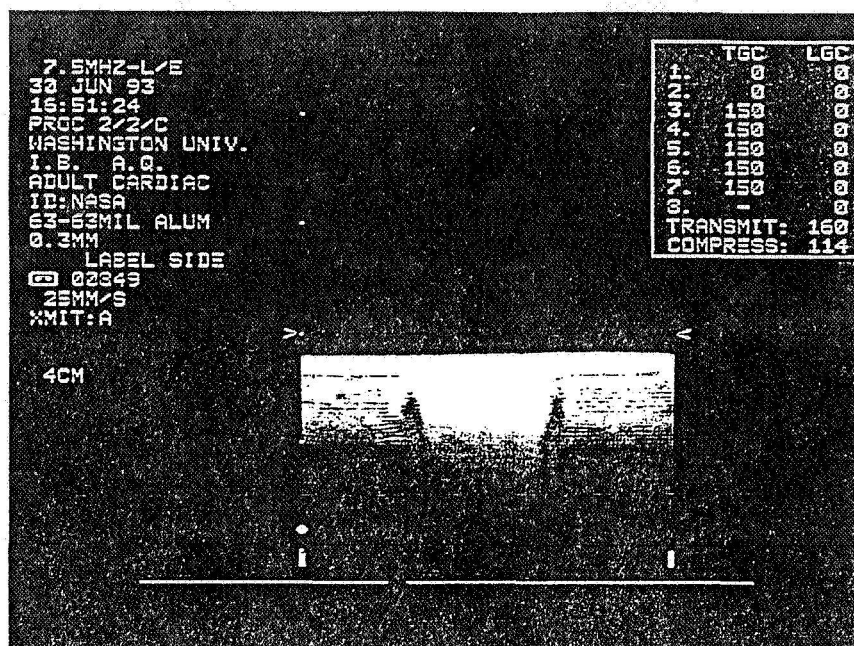
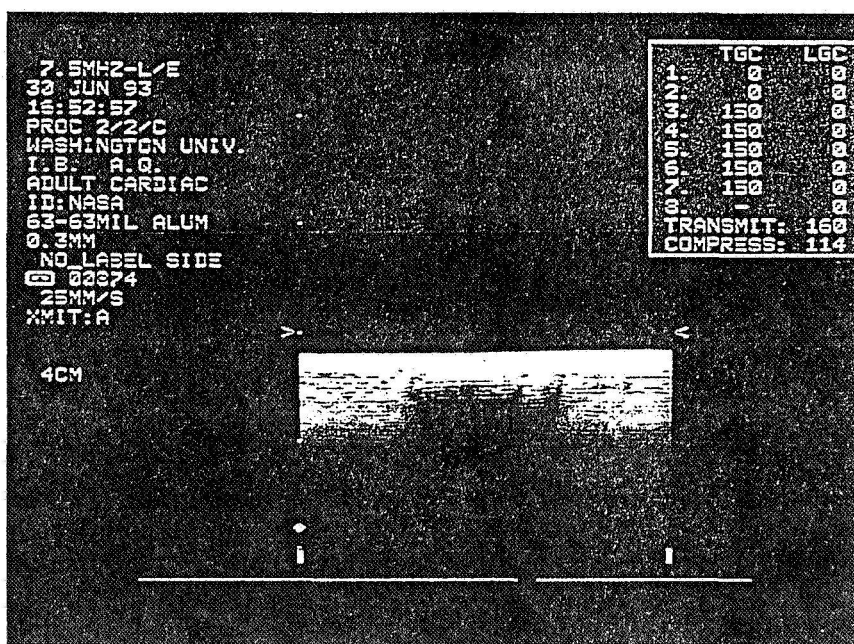
**Figure 4:** Linear array images over the disbonded region for specimen #1. Figure 4a shows the B-scan image of the disbonded region obtained from the "bottom" side of the specimen. Figure 4b shows the B-scan image of the disbonded region obtained from the "top" side of the specimen.

Figure 4 shows the linear array images over the disbanded region for specimen #1 from both sides. In Figure 4a the region of disbond can be clearly distinguished from the surrounding well-bonded region in the image. This image was obtained from the "bottom" side of the specimen where the masking tape was adhered to the aluminum plate. As described above, the B-scan image represents the returned signals from many round-trip echoes (reverberations) inside the specimen and does not represent a single cross-section through the depth of the specimen. Comparing the disbanded region with the surrounding bonded region in this image it appears that different echo decay patterns can be observed. The echo decay pattern corresponding to the disbanded region appears "brighter" than the surrounding regions and appears to monotonically decrease in brightness as time increases. Furthermore, the individual

Figure 4b shows the B-scan image of the disbonded region of specimen #1 obtained from the "top" side of the specimen. In this image the region of disbond can again be clearly distinguished from the surrounding well-bonded region although it appears much different than that observed when imaged from the "bottom" side of the specimen (Figure 4a). The image in Figure 4b shows the disbonded region to be much darker than the surrounding well-bonded

regions. This appears to be indicative of a higher attenuation of ultrasound in the disbond region and hence a more rapid rate of echo decay when imaged from the "top" side. Although the disbond region looks very different when Figures 4a and 4b are compared, the well-bonded regions appear to be very similar in the two images. We would expect the images from the well-bonded regions to be very similar when imaged from both sides of the specimen because the thickness of each of the aluminum plates is the same and hence the ultrasound propagates along the same path in both cases.

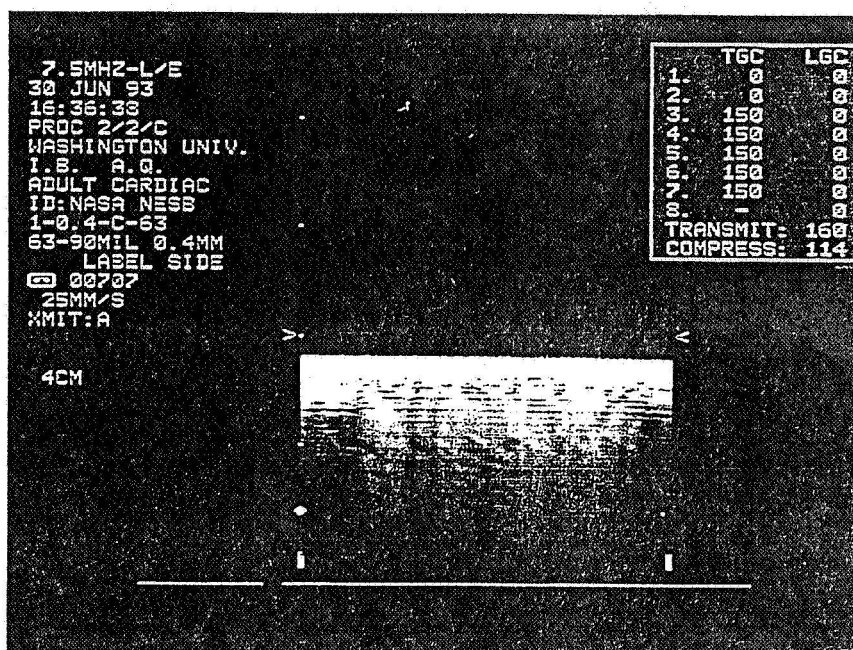
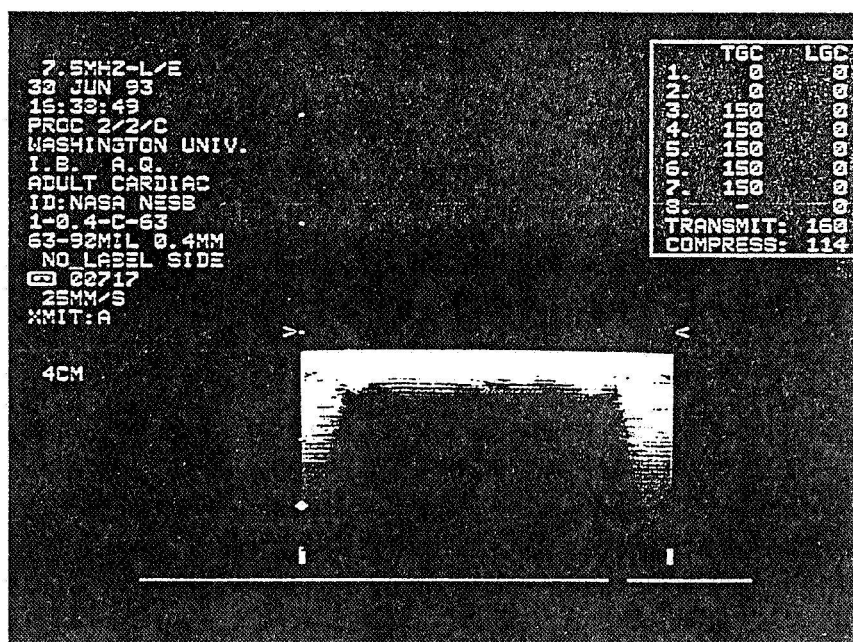
**Figure 5 :** Linear array images over the disbonded region for specimen #2. Figure 5a shows the B-scan image of the disbonded region obtained from the "bottom" side of the specimen. Figure 5b shows the B-scan image of the disbonded region obtained from the "top" side of the specimen.

Figure 5 displays the B-scan images obtained from specimen #2. Figure 5a shows the B-scan image obtained when specimen #2 is interrogated from the "bottom" side of the specimen; the side in which the masking tape was adhered to the "bottom" plate. The image from the "top" side of the specimen is depicted in Figure 5b. The disbond region is again clearly distinguished from the surrounding well-bonded regions in both of these figures. Many of the same features are apparent in these images of specimen #2 as were observed in the images of specimen #1 (Figure 4); e.g., the disbond region appears "brighter" compared to the well-bonded region when specimen #2 is imaged from the "bottom" side (Figure 5a) and much darker than the well-bonded region when imaged from the "top" side (Figure 5b).

There are some interesting differences between the images obtained from specimen #1 and the images obtained from specimen #2 in the well-bonded regions. In contrast to that observed for specimen #1, the echo patterns from the well-bonded regions do not look the same when specimen #2 is interrogated from the "bottom" compared to the images obtained from the "top". The difference in the observed echo pattern corresponding to well-bonded regions may be related to the different thickness of aluminum plate present at the surface of interrogation. The sequence in which a transmitted ultrasonic pulse encounters an aluminum/epoxy interface is different for the two sides of specimen #2. Furthermore, the images of the well-bonded regions of specimen #2 do not appear to have the same modulation pattern of image brightness as observed for specimen #1.

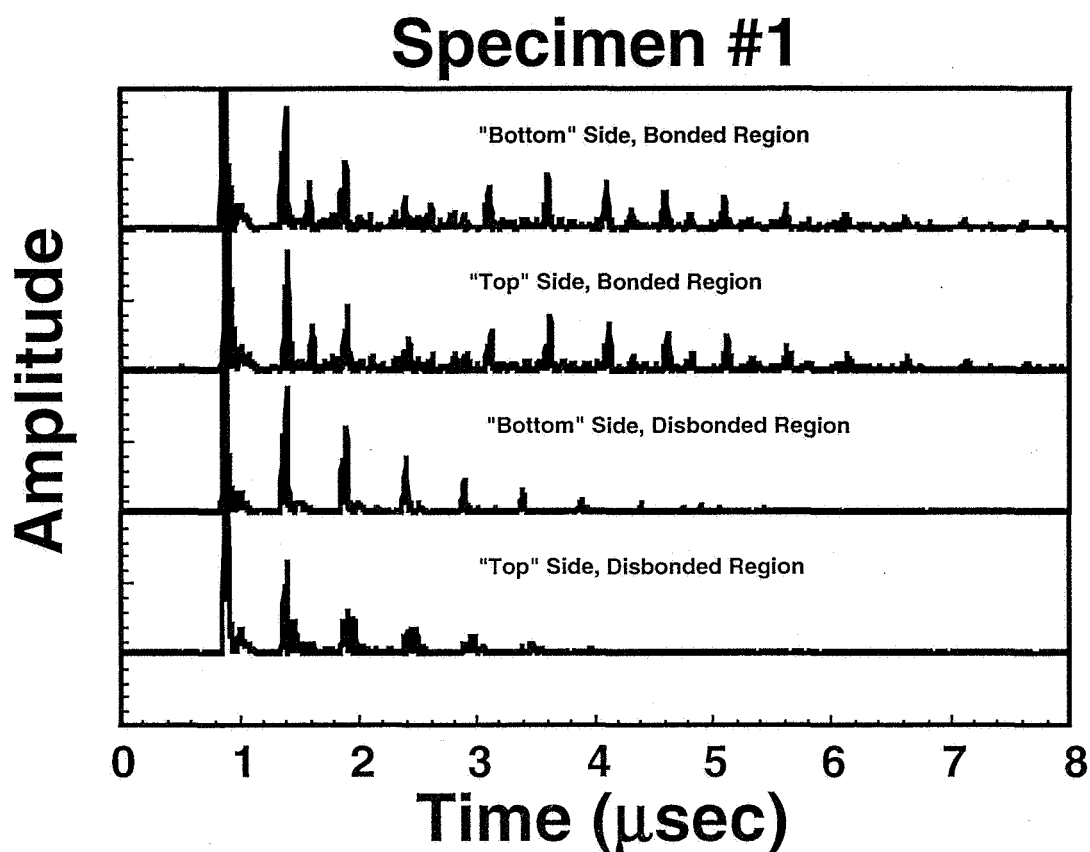
**Figure 6:** Representative rf A-line amplitude signals obtained from each of the specific regions of specimen #1.

Figure 6 shows that the amplitude echo decay pattern from the disbonded region of the "bottom" side of specimen #1 has a different shape than the rf A-lines obtained from the well-bonded region. The echo amplitudes from the disbonded region appear to decrease monotonically in time. Time between interface echoes in this region is approximately 0.50  $\mu$ sec, which corresponds to a round-trip distance of 0.32 cm in aluminum, twice the thickness of the bottom aluminum plate. Furthermore, it appears that there is not as much backscattered signal occurring between the interface echoes, suggesting that sound does not propagate easily beyond

the aluminum-tape interface from this side. The echo decay pattern from the disbonded region of specimen #1 obtained from the "top" side is also shown in Figure 6. This echo decay pattern demonstrates an apparent monotonic decrease in echo amplitude with time and it appears that this decrease in amplitude is at a greater rate than that observed for the disbonded region when measured from the "bottom" side. This A-line, obtained from the disbonded region of the "top" side, appears to have a significant amount of signal after the larger interface echoes. We hypothesize that the observed differences between the rf A-lines obtained from the disbond region of the "top" plate and the rf A-lines obtained from the disbond region of the "bottom" plate may be a consequence of the specific nature of the disbond/aluminum interfaces occurring at the "top" and "bottom" plates.

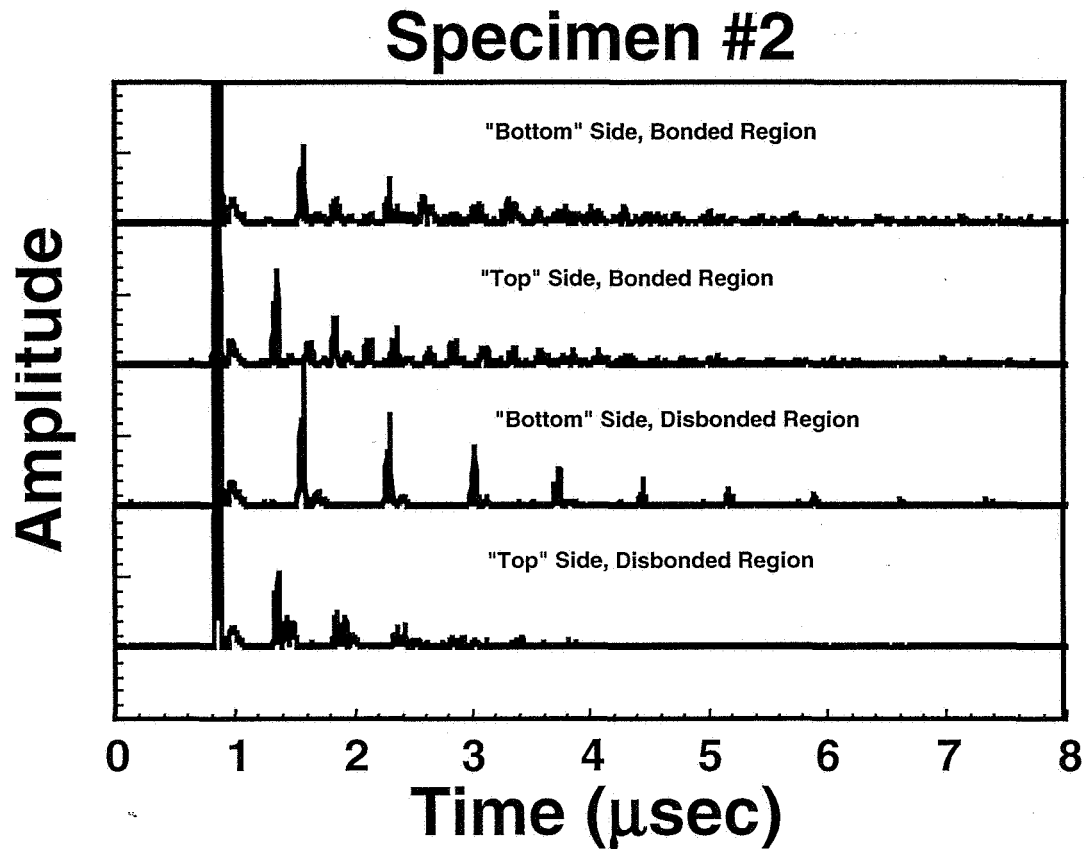
**Figure 7:** Representative rf A-line amplitude signals obtained from each of the specific regions of specimen #2.

Figure 7 depicts the corresponding representative rf A-line signals (amplitude) obtained from each of the specific areas of specimen #2. The echo decay patterns for the well-bonded region from the two sides of the specimen ("bottom" and "top") do not appear to be the same as

they did for specimen #1. This is to be expected because the "bottom" and "top" aluminum plates are of different thicknesses for specimen #2 and the ultrasound propagates through the different layers of the specimen in a different sequence. The rf A-lines from this well-bonded region of specimen #2 do not appear to demonstrate such a strong modulation of the echo amplitudes with time. These A-lines show a significant amount of signal between the larger interface echoes, similar to that observed for specimen #1, which is due to multiple reverberations within the specimen.

As was observed for specimen #1, Figure 7 shows that the amplitude echo decay pattern from the disbonded region of the "bottom" side of specimen #2 has a different shape than that observed for the well-bonded region. The echo amplitudes from the disbonded region appear to decrease monotonically in time for specimen #2 as they did for specimen #1. Measurement of the time between interface echoes in this region provides a round-trip time of approximately 0.72  $\mu$ sec, which corresponds to a round-trip distance of 0.45 cm in aluminum, twice the thickness of the "bottom" aluminum plate of specimen #2. Furthermore, as was observed for specimen #1, it appears that there is not as much signal occurring between the interface echoes, suggesting that sound does not propagate easily beyond the aluminum-tape interface from this side. The echo decay pattern from the disbonded region of specimen #2 obtained from the "top" side is also shown in Figure 7. As found for specimen #1, this echo decay pattern also appears to demonstrate a decrease in signal amplitude at a greater rate than that observed for the disbonded region when measured from the "bottom" side. Again this is indicative of a greater attenuation of the signal and may be related to the specific nature of the aluminum/disbond interface. As was observed in specimen #1, there appears to be a significant amount of scattered signal after the larger interface echoes when compared with the signal obtained from the "bottom" side.

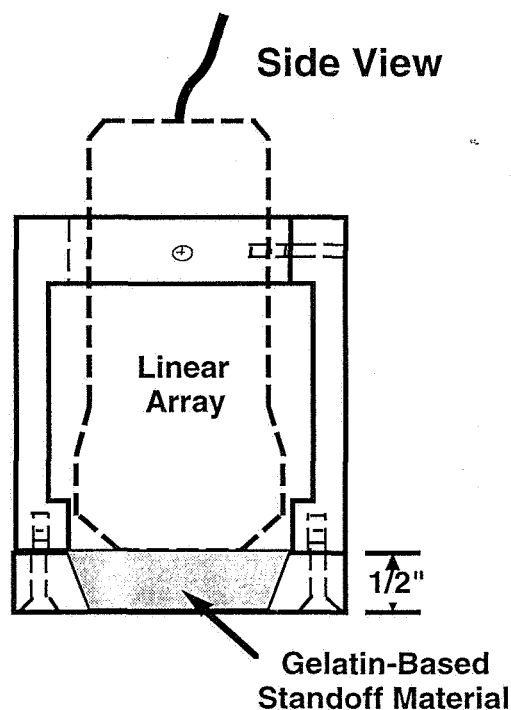
**Figure 8:** Standoff/delay fixture designed for use with the 7.5 MHz linear array probe.

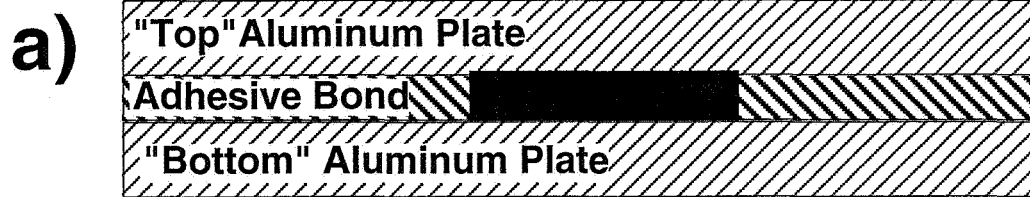
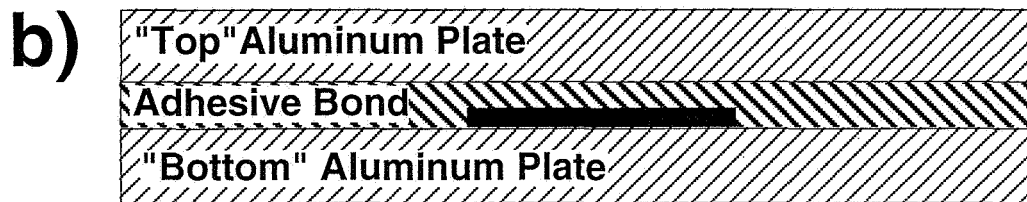
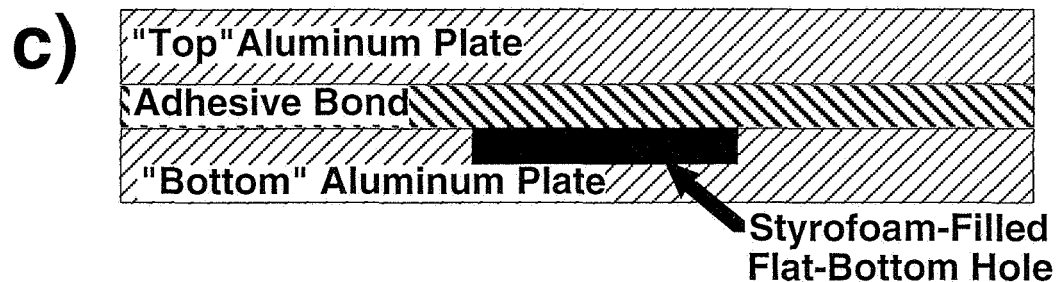
**Figure 9:** Diagram illustrating the three types of bonded-aluminum specimens interrogated: (a) complete disbond specimen, (b) localized disbond specimen, and (c) styrofoam-filled, flat-bottom hole specimen.

The third type of bonded aluminum plate specimen interrogated, was a bonded aluminum plate specimen with a series of flat-bottom holes backfilled with Styrofoam. This specimen consisted of 0.13 cm thick aluminum plates adhesively bonded together with type PR-1422 sealant obtained from Trans-World Airlines. The "bottom" aluminum plate had four regions of simulated corrosion consisting of 0.065 cm deep flat-bottom holes with diameters of 2.54cm (1-inch), 1.27cm (1/2-inch), 0.64cm (1/4-inch), and 0.32cm (1/8-inch), all backfilled with Styrofoam. Figure 9(c) illustrates the construction of this specimen with the Styrofoam-filled flat-bottom holes.

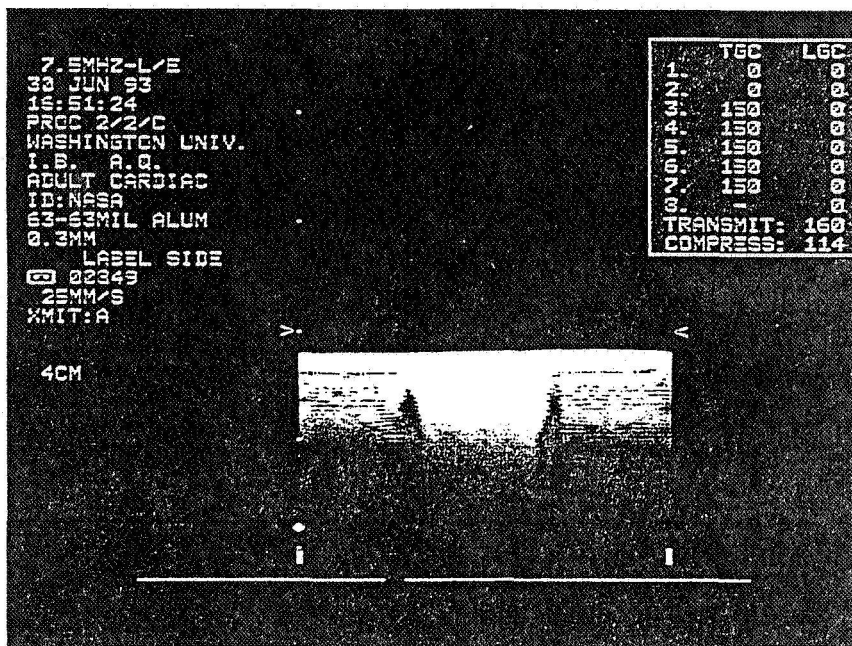
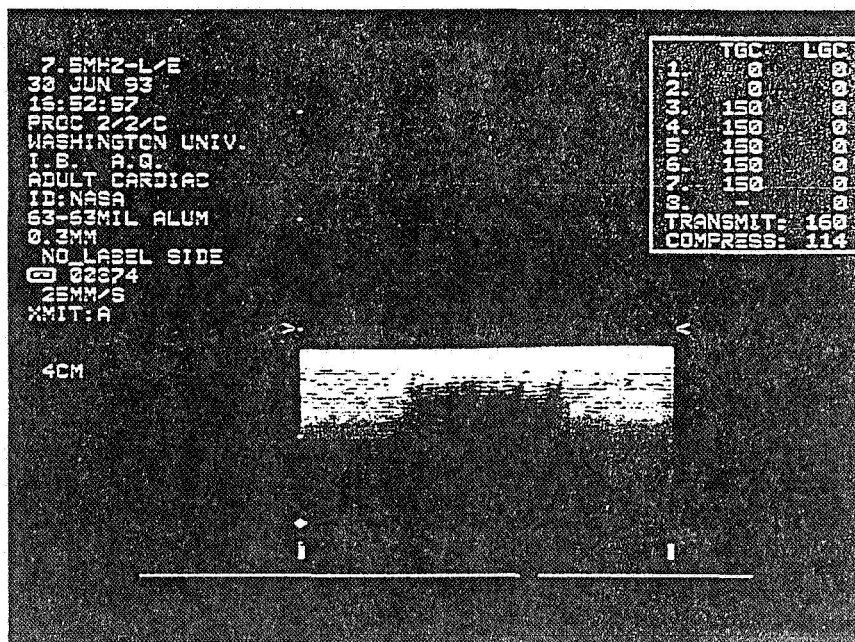
**Figure 10:** Linear array images over the disbonded region for complete disbond specimen. Figure 10a shows the B-scan image of the disbonded region obtained from the "bottom" side of the specimen. Figure 10b shows the B-scan image of the disbonded region obtained from the "top" side of the specimen.

The first set of images are of the bonded aluminum plates containing the complete disbond spanning the entire bond thickness between the "top" and "bottom" aluminum plates. In the first segment of videotape, the images obtained from the "bottom" side of the specimen where the masking tape was adhered to the aluminum plate are presented. The region of disbond can be readily distinguished from the surrounding well-bonded region in these images. These B-scan images represent the returned signals from many round-trip echoes (reverberations) inside the specimen which produce an entirely different echo decay pattern corresponding to the disbonded region when compared to the well-bonded region. The echo decay pattern corresponding to the disbonded region appears "brighter" than the surrounding regions and appears to monotonically decrease in brightness as time increases. Furthermore, the individual echo patterns do not appear as prominent in the disbond region as those observed in the surrounding regions thus giving the disbond region a more "smooth" appearance. The brightness

of the echo pattern from the well-bonded region appears to be more modulated and the individual echoes appear more prominently. The vertical dark lines which periodically appear in the images are probably the result of air bubbles present at the surface interface between the gelatin standoff and the specimen. These air bubbles at the surface "shadow" the ultrasound producing the dark lines.

bonded region although it appears quite different than that observed when imaged from the "bottom" side of the specimen. The disbonded region appears to be much darker than the surrounding well-bonded regions when imaged from the "top". This appears to be indicative of a higher attenuation of ultrasound in the disbond region and hence a more rapid rate of echo decay when imaged from the "top" side. Although the disbond region looks very different when the images obtained from the "top" and "bottom" are compared, the well-bonded regions appear to be very similar in the two images. We would expect the images from the well-bonded regions to be very similar when imaged from both sides of the specimen because the thickness of each of the aluminum plates is the same and hence the ultrasound propagates along the same path in both cases. Figure 10 shows still-frame linear array images of this specimen obtained from both sides.

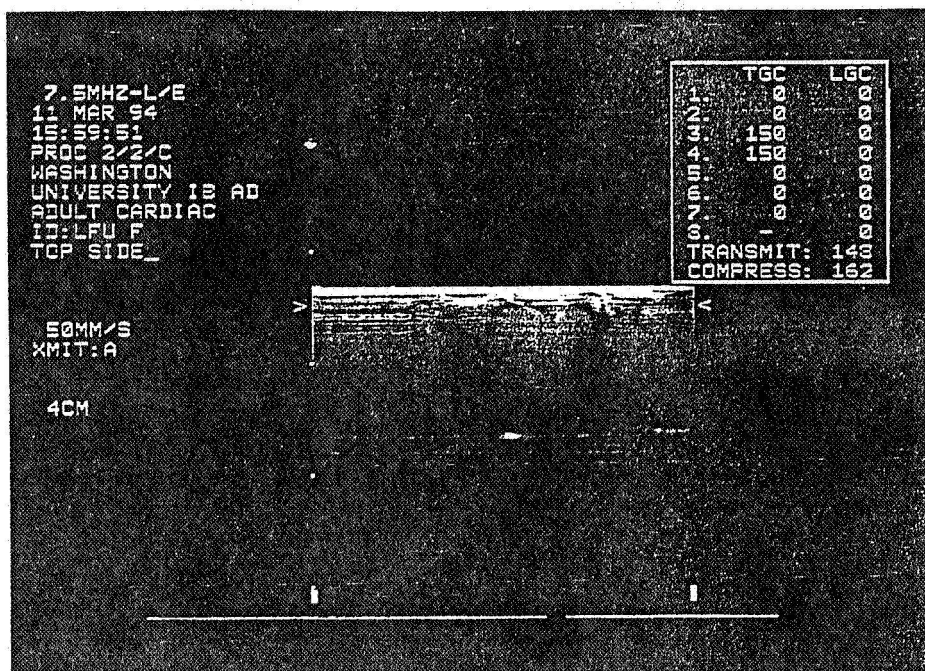
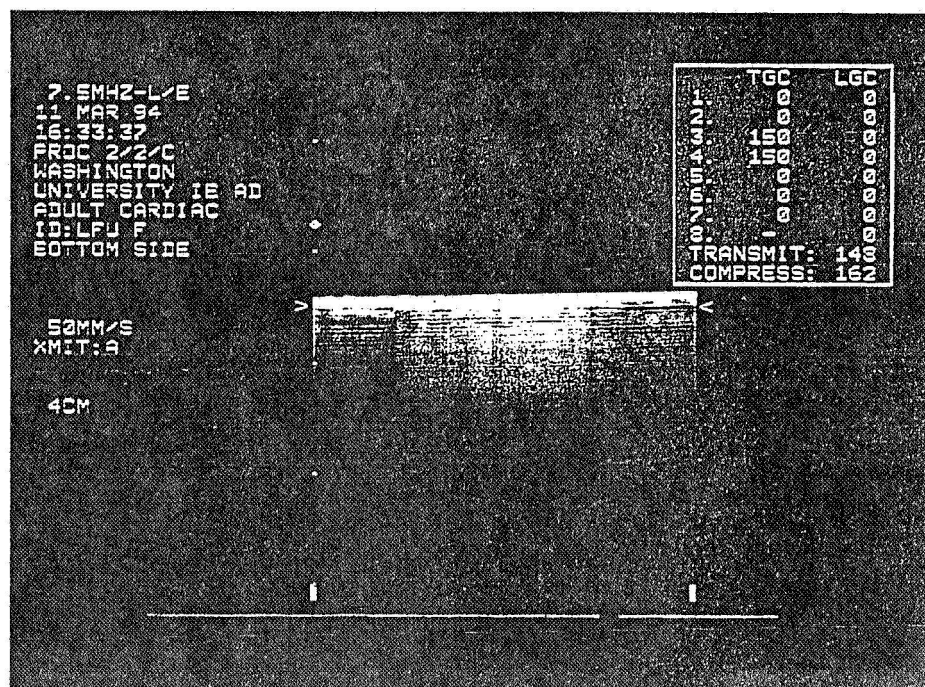
**Figure 11:** Linear array images over the disbonded region for the localized disbond specimen. Figure 11a shows the B-scan image of the disbonded region obtained from the "top" side of the specimen. Figure 11b shows the B-scan image of the disbonded region obtained from the "bottom" side of the specimen.

Images in the next segment of videotape show the bonded aluminum plate specimen with a localized disbond. In the first set of images the specimen is interrogated from the "top" side. In this case ultrasound must propagate through the "top" aluminum plate and through the adhesive bond before encountering the disbonded region. The disbonded region can be readily discerned when the linear array is positioned such that both the well-bonded and disbond regions are visible simultaneously, although the image of the disbond is significantly different than that observed for the complete disbond as described above. The localized disbonded region appears as a "distorted" echo decay pattern and does not have the more uniform appearance of the of the complete disbond presented above.

In the next segment of videotape the linear array is used to image the localized disbond specimen from the "bottom" aluminum plate. In this case the interrogating ultrasound encounters the localized disbond before traversing the entire adhesive bond. Images of the localized disbond obtained from the "bottom" side are significantly different than that obtained from the "top" side. Images over the disbonded region show the echo decay pattern to persist significantly longer and appear somewhat "brighter" compared with the well-bonded region when imaged from the "bottom". This suggests that the reverberated ultrasound encounters less attenuation as the ultrasonic signals are "ringing" in the bottom plate and are not propagating into the adhesive bond. Figure 11 shows still-frame linear array images of this specimen obtained from both sides.

The images of the localized disbond specimen also show a significant difference in the observed echo decay pattern when the disbonded region is imaged from the two sides of the specimen. Images of the disbonded region obtained from the "top" side of the specimen show the echo decay pattern associated with the disbond region to be distinct from the well-bonded region but does not have a uniform echo decay pattern across the width of the disbonded region. This may be due to the fact that the ultrasound must traverse the entire bond thickness before encountering the disbond and the echo decay pattern consists of contributions arising from the "top" plate to bond interface and bond to localized disbond interface. Both of these contributions will combine to form a somewhat complex echo decay pattern. Images of the localized disbond obtained from the "bottom" side of the specimen show a significantly different echo decay pattern. In this case the echo decay pattern is more uniform and appears "brighter" than the surrounding well-bonded region. This observation seems to be consistent with what might be expected when the localized disbond is imaged from this side. One hypothesis is that the ultrasound is reverberating in the "bottom" plate and very little is being transferred through the localized disbond and into the bond region; hence resulting in the "bright", relatively non-attenuating echo-decay pattern.

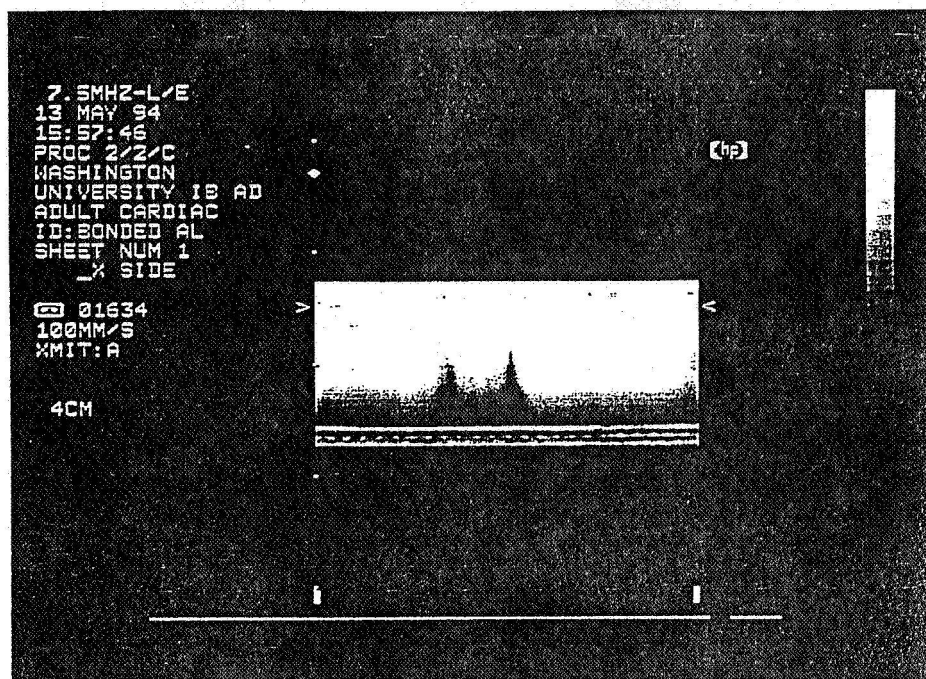
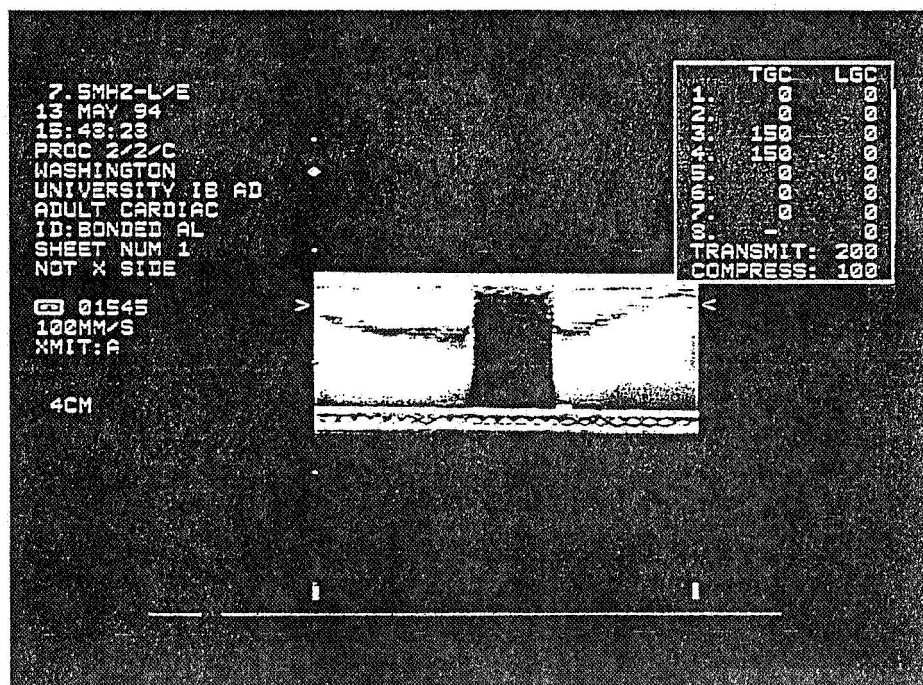
**Figure 12:** Linear array images over the disbonded region for styrofoam-filled flat-bottom hole specimen. Figure 12a shows the B-scan image of the disbonded region obtained from the "top" side of the specimen. Figure 12b shows the B-scan image of the disbonded region obtained from the "bottom" side of the specimen.

In the next segment of videotape, the specimen is interrogated from the "bottom" side. In this configuration, the ultrasound encounters the flat-bottom hole prior to traversing the adhesive bond. In this case we obtain a much different image of the Styrofoam-filled flat-bottom holes. Here the position of the flat-bottom holes are much easier to observe. Images of the 1-inch diameter flat-bottom hole appear dark when compared to the surrounding well-bonded region indicating a high degree of attenuation of the reverberating ultrasonic signals. Similar images are observed for the 1/2-inch diameter, 1/4-inch diameter, and 1/8-inch diameter flat bottom holes. Figure 12 shows still-frame linear array images of this specimen obtained from both sides.

The linear array images of the bonded-aluminum plate specimen with the Styrofoam-filled flat-bottom holes also show a significant difference between the images obtained from the "top" and "bottom" of the specimen. When imaged from the "top" plate the flat-bottom holes are very difficult to identify. In this case the ultrasound must traverse the entire bond thickness before encountering the Styrofoam-filled flat-bottom holes. Here, as with the localized disbond specimen when imaged from the "top" side, the resultant echo decay pattern is the result of a complex combination of interface echoes occurring at the "top" plate-adhesive bond and bond-Styrofoam interfaces. Apparently the acoustic impedance mismatch between the adhesive bond and Styrofoam is not significantly different than the impedance mismatch between the adhesive bond and aluminum and thus the observed echo decay pattern is not significantly altered. When this specimen is imaged from the "bottom" side the Styrofoam-filled flat-bottom holes are readily apparent. In this case the echo decay pattern associated with the flat-bottom holes shows up dark relative to the well-bonded region. One hypothesis might be that the ultrasound propagates through the "bottom" aluminum plate and into the Styrofoam where it is absorbed. Hence the

echo decay pattern is more highly attenuated and shows up dark relative to the well-bonded region.

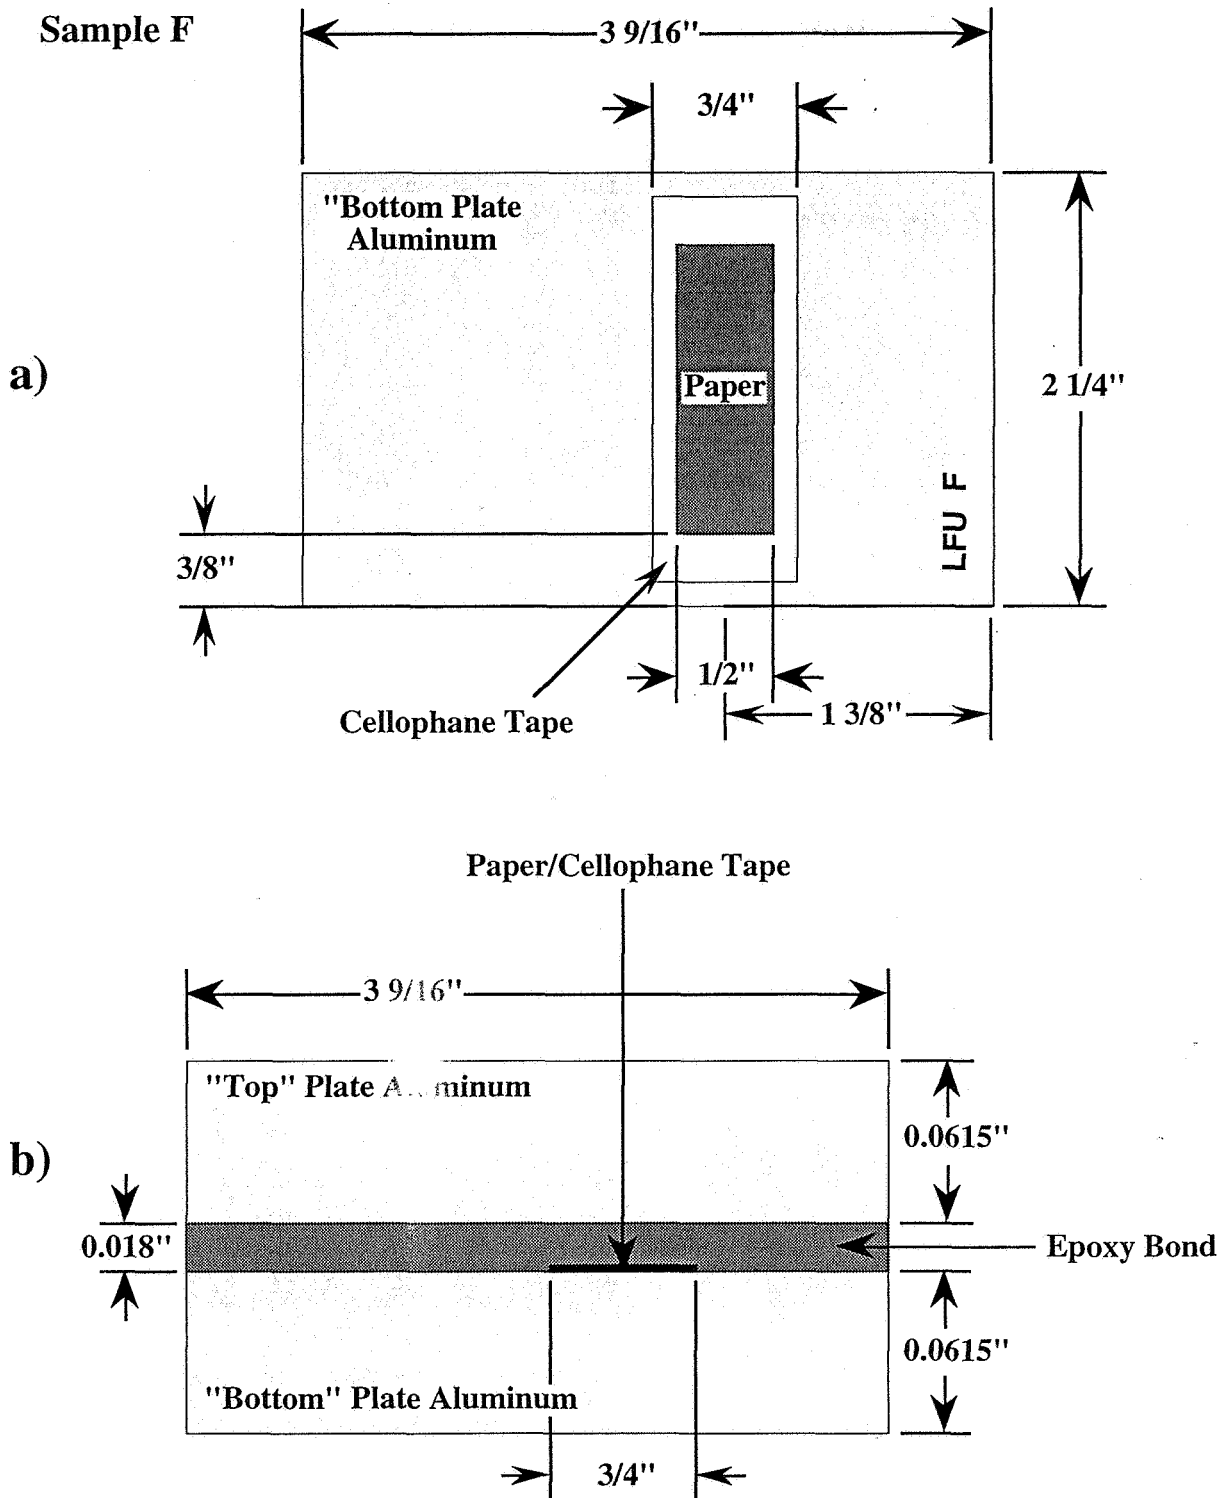
**Figure 13:** Illustration of the construction of the sample F (the bonded aluminum plate sample). a) Looking down on the "bottom" plate b) A cross-sectional representation, the horizontal dimension is to scale while the vertical dimension is exaggerated (x 3.4) for clarity.

specimens were machined to their final length and width dimensions leaving only one area of simulated disbond. The final thickness of sample F was 0.141". Figure 13 illustrates how sample F was constructed.

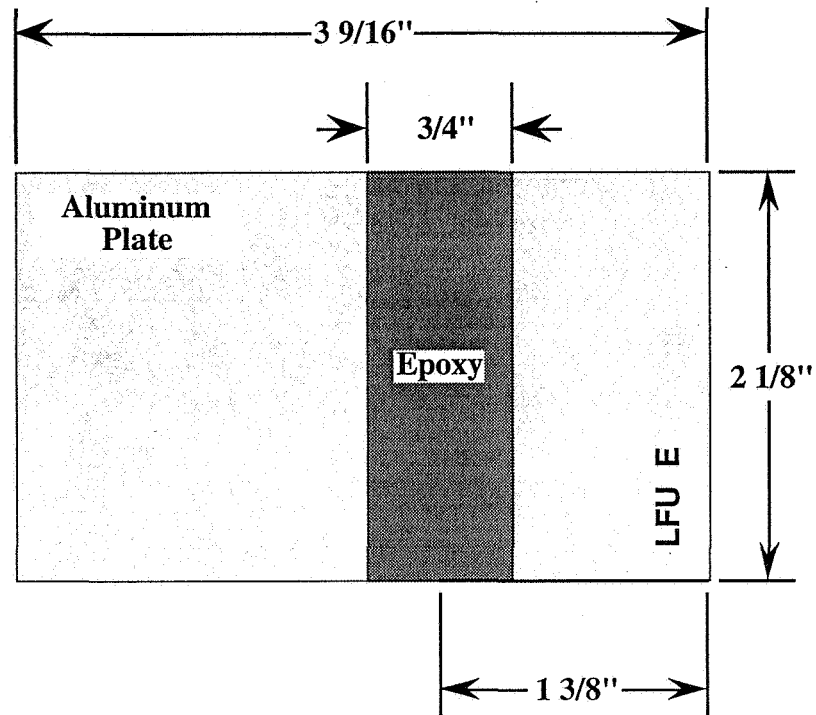
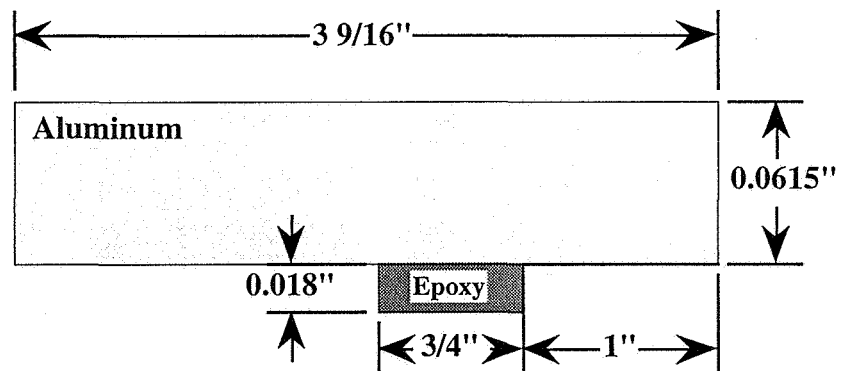
**Sample E****a)**

**Figure 14:** Illustration of the construction of the sample E (the aluminum plate with epoxy sample). a) Looking down on the aluminum plate b) A cross-sectional representation, the horizontal dimension is to scale while the vertical dimension is exaggerated (x 3.4) for clarity.

In order to compare the effects on the reflected ultrasound at the aluminum/paper interface ("disbond") to the well-bonded regions of sample F, a single plate aluminum sample (sample E) was constructed with a strip of epoxy applied to one side. The aluminum plate was 3 9/16" in length by 2 1/8" wide and 0.0615" thick and the epoxy strip was 3/4" wide by 2 1/8" long. The measured total thickness of the resultant aluminum plus epoxy region was 0.0729". Figure 14 illustrates the construction of the aluminum/epoxy-strip sample.

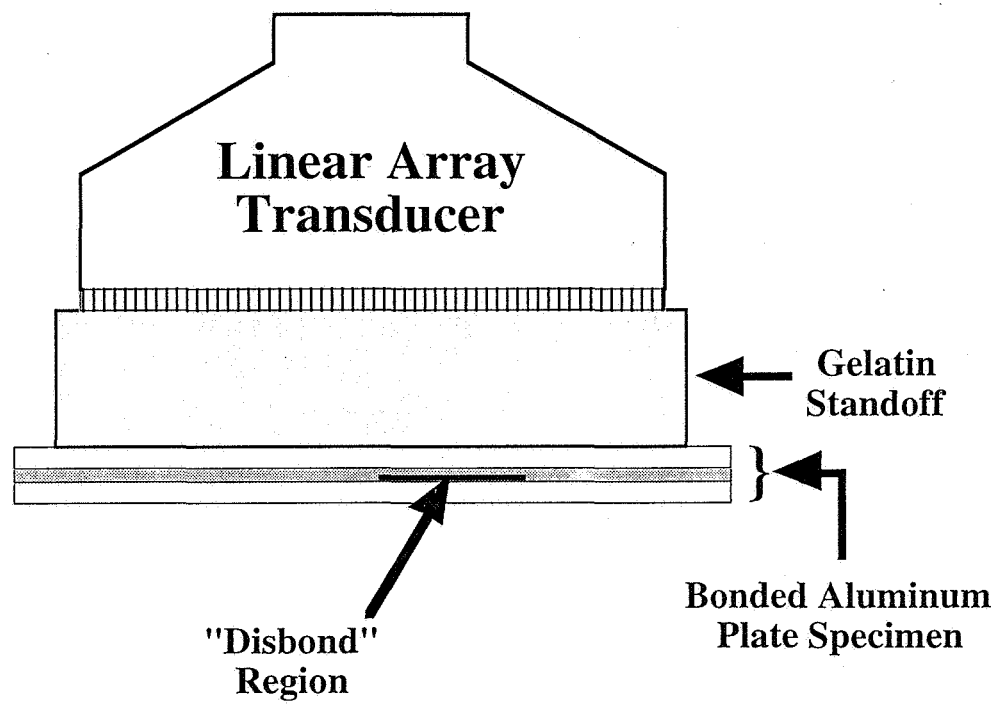
**Figure 15:** Configuration of linear array transducer and gelatin standoff for obtaining images of the samples.

The aluminum plate samples were imaged with an unmodified Hewlett-Packard SONOS 1500 medical imaging system in the peripheral vascular imaging mode. A nominal 7.5 MHz center-frequency linear array probe was used with an overall length of 1.5 inches. Between the sample and the linear array probe a gelatin stand-off was employed as illustrated in Figure 15. The gelatin stand-off served to move the front surface echo of the aluminum specimens closer to the center of the image. Each sample was imaged with the axis of the linear array along the long axis (length dimension) of the sample so that the linear array straddled the disbond region. The transmit power level of the SONOS 1500 imaging system was kept constant and the same depth dependent gain (time-gain compensation) was applied to all depth segments for all the measurements. For each sample interrogated the video compression was adjusted to optimize the image contrast and remained constant.

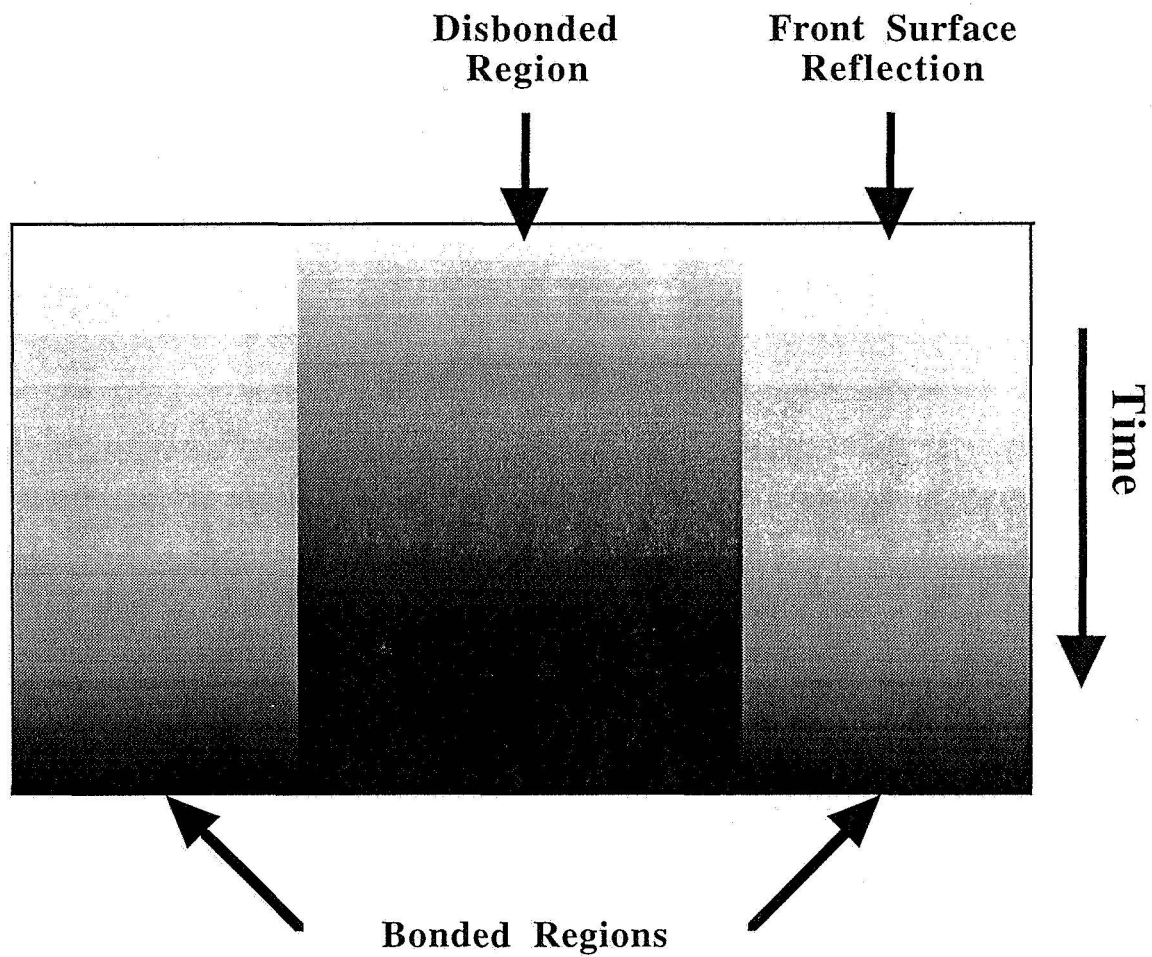
## Cartoon Depicting Typical Linear Array Images

**Figure 16:** Cartoon illustrating how to interpret the linear array images.

Figure 16 illustrates how to interpret the images presented of the samples obtained with the linear array system. For sample F the images were acquired with the linear array straddling the disbond region (imaged from the "top" plate side and the "bottom" plate side). For sample E, the aluminum plate plus the epoxy strip sample, the linear array insonified from the aluminum plate side of the sample straddling the epoxy strip. As discussed in Section III, these images are

composed of many reverberations of the ultrasonic signal in the sample and do not represent a single cross-sectional view. The general pattern seen in the images (as depicted in Figure 16) will be lightly shaded regions on either side of the disbond region for sample F and the epoxy strip region for sample E. The center portion of the image will display a characteristic reverberation pattern dependent on the type of interfaces encountered for the given sample. In the areas of the image representing the disbond region of sample F the exact shading of the reverberating signal will depend on the side of insonification.
